Tesla Model 3 Susceptibility to Sudden Unintended Acceleration

Ronald A. Belt
Plymouth, MN [REDACTED]

1 May 2023

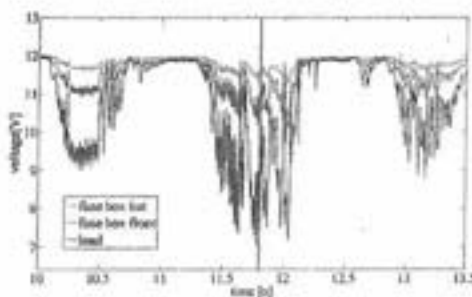
Fig. 12. Voltage spikes on the "12V" supply line of an ICE vehicle as caused by an electronic power steering (EPS) system during a slalom maneuver.^[20]

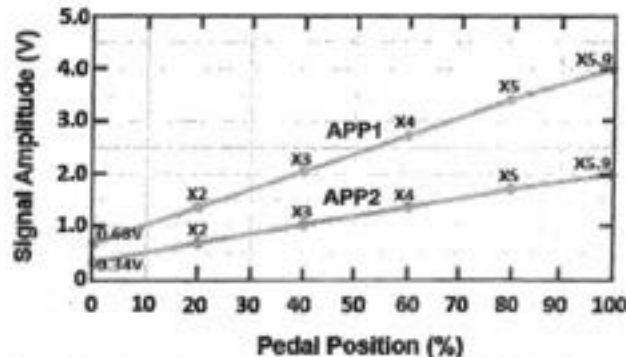
Figure 13 shows the values X in Table 3 that multiply the released APP sensor signals after they have been calibrated superimposed on the transfer function (APP sensor voltage vs pedal depression) of the normal APP sensor signals. One can see that the released APP sensor signals, when corrected for a decrease in the "1.65V" calibration voltage, lie on the same transfer function as the original APP sensor signals, making it clear that they will pass all tests performed on the original APP sensor signals.

Figure 13. APP signal transfer functions showing that multiplying the released pedal values by the factors xN produces values that lie on the same curves as the original transfer functions, allowing the corrected signals to pass all tests performed on the original APP signals.

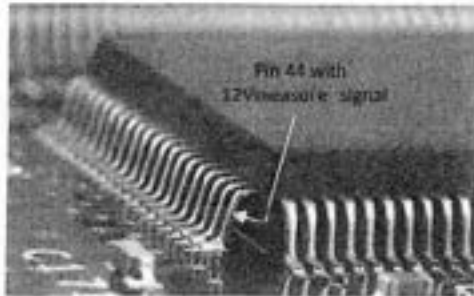
Figure 14A. DSP pin 44 with the "12V measure" signal is the last pin on the left.

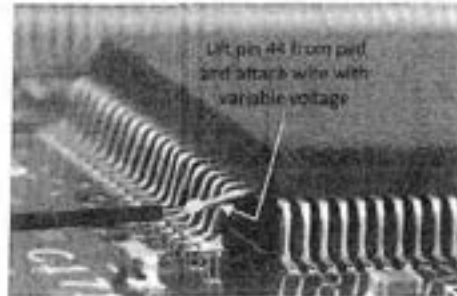
Figure 14b. Lift DSP pin 44 and attach a wire with a variable voltage.

constant at 5V scaled down to 1.65V, then the inverter will run normally with torque being varied by pressing the accelerator pedal. But if one changes this voltage to 0.281V or less, which can happen when the 12V supply dips temporarily to 2.14V, then the APP sensor outputs will read 4V and 2V, which is equivalent to flooring the accelerator pedal. This causes sudden unintended acceleration without the driver pressing on the accelerator pedal.

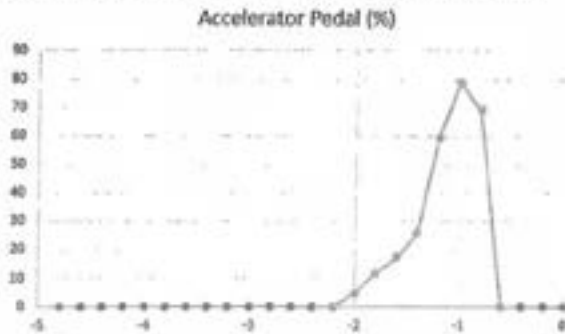
Fig A1. EDR data for a female driver approaching a garage on a level driveway^[24]

At first it would seem that both these signals were made by drivers pressing on the accelerator pedal instead of the brake pedal. This is a common conclusion when it is believed that the signals can be non-zero only when the driver is pressing on the accelerator pedal. Whoever believes these EDR APP sensor signals were made by drivers pressing on the accelerator pedal instead of the brake pedal must also explain the similarity between the two signals even though they were produced by two different drivers in vastly different situations. This similarity lies not only in the large amplitudes of the two signals, but also in the similarity of the two rise times; namely, a slow one lasting for about 0.8 seconds followed by a faster one that rises to a maximum in less than a half a second. Are we to believe that two drivers of different sexes and in two entirely different driving situations could press the accelerator pedal inadvertently at almost exactly the same rates of movement with a slow depression first followed by a faster occurring at almost the same time later? This author believes not.

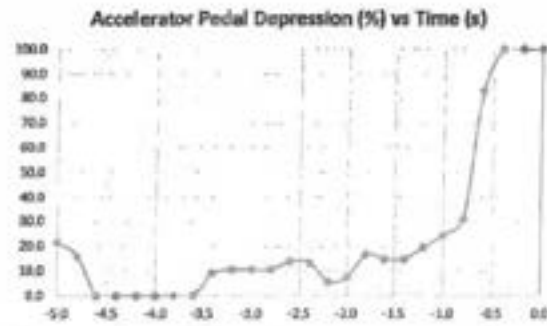
Fig A2. EDR data for a male driver going down-hill in a parking ramp^[25]

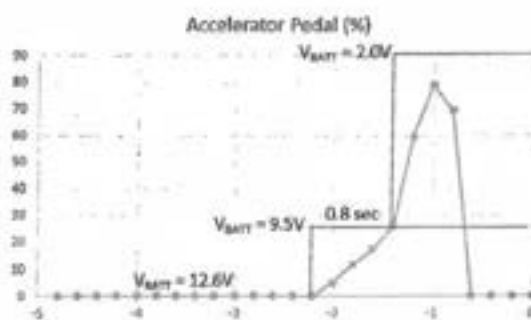
Fig A3. EDR data shows two step functions with V_{BATT} 's equal to 9.5V and 2.0V separated by 0.8 sec

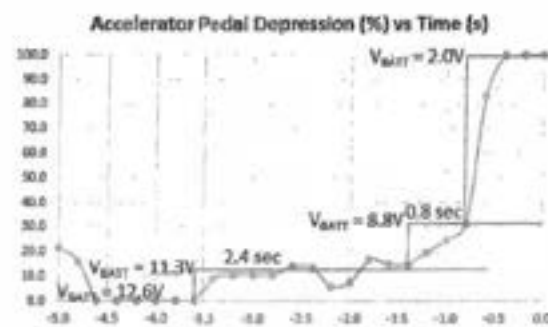
Fig A4. EDR data shows three step functions with V_{BATT} 's equal to 11.3V, 8.5V, and 2.0V separated by 2.4 sec and 0.8 sec
