Tesla Model 3 Susceptibility to Sudden Unintended Acceleration

Ronald A. Belt
Plymouth, MN [REDACTED]

1 May 2023

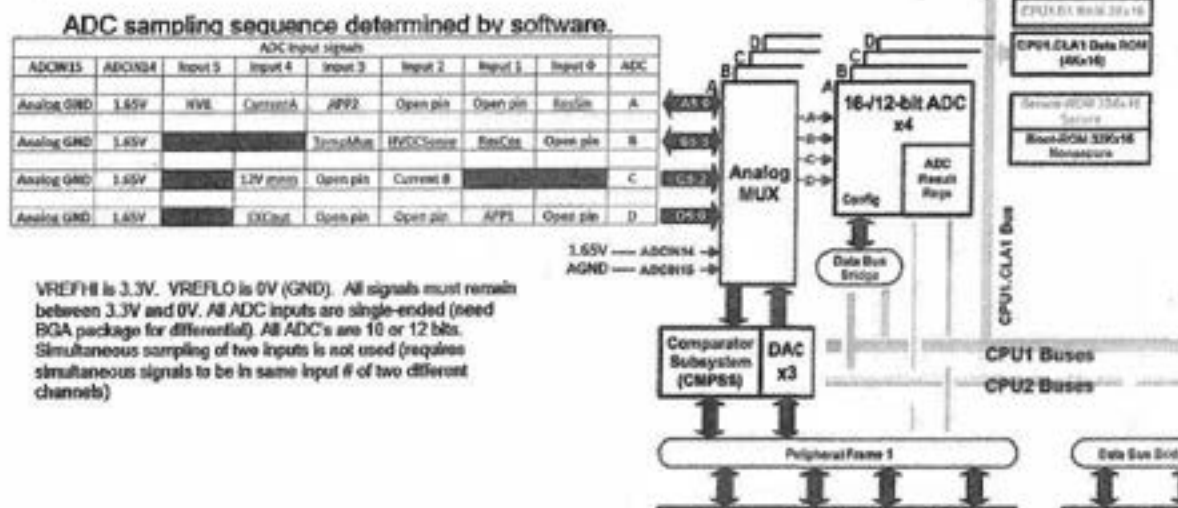
Figure 8. Assignment of signals to the four TMS320F28377 ADC's as determined by Table 2. Notice that the "1.65V" signal is common to all four ADC's.

So, which pair of similar signals requires the same calibration? After all, it is possible that only one pair of ADC’s requires the same calibration, while the other two ADC’s have a different calibration. But if we look at the table in Figure 8, we see that all three pairs of signals use ADC A. Therefore, if the “1.65V” signal is used to calibrate ADC channels A and B, but not ADC channels C and D, then ADC channels A and B carrying ResSin and ResCos would both be calibrated along with CurrentA and Throttle2. But signals CurrentB and Throttle 1 in ADC channels C and D would have different calibrations, which would increase the error for these two pairs of signals. Since this can’t be tolerated, ADC’s C and D must also be calibrated with the same “1.65V” signal as ADC A. Therefore, one must conclude that the “1.65V” signal is used to calibrate all four of the ADC channels with the same calibration. There is no other reason to digitize the same “12V measure” signal using four different ADC channels other than to calibrate all four ADC channels with the same calibration.

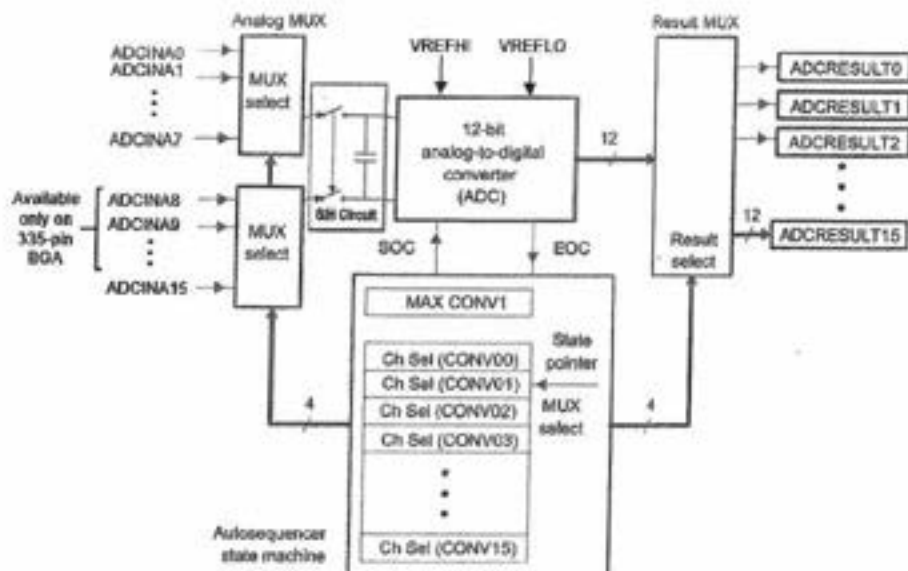
Figure 9. Functional block diagram of the TMS320F28377 ADC circuit showing how the order of signal sampling is determined by software manipulating a pointer in a sequencer

Figure 9 shows two other interesting features. The first feature is that input pins numbered ADCINx9 and higher, which are used for differential inputs to the ADC's, are not available on the 176-pin version of the DSP chip used in the Model 3, but only on the 343-pin BGA version of the DSP chip. This means that all ADC inputs in the Model 3 inverter must be single-ended signals between 0V and $VREFHIx > 0V$, which requires translating signals with plus and minus values, like the sin and cos signals from the resolver, into single-ended signals between 0V and $VREFHIx$ before applying them to the ADC inputs. It also means that all ADC converters in the Model 3 inverter can only be configured as 10-bit or 12-bit ADC's and not as 14-bit or 16-bit ADC's because the latter two require the use of differential inputs. The second feature is that the maximum and minimum signal amplitudes to be converted can be configured separately for each ADC. The maximum signal amplitude can be anywhere between 0V and 3.3V if $VREFHIx$ is equal to the ADC bias voltage of $VDDA = 3.3V$. The minimum signal amplitude can be any voltage below the maximum signal voltage for differential signals, which is not allowed by the 176-pin version of the DSP used in the Model 3, or only 0V for single-ended signals. Therefore, the Model 3 single-ended signals must lie between 0V and 3.3V maximum. TI, the manufacturer of the DSP chip, recommends that $VREFHIx$ be set at 3.0V. However, Damien Maguire has measured that $VREFHIx$ is actually set at 3.3V by Tesla. This may have done to avoid the need for a special 3.0V regulator device on the PWB. If any ADC signals exceed 3.3V by 300mV or more, then the ADC will give an incorrect result and may be permanently damaged.

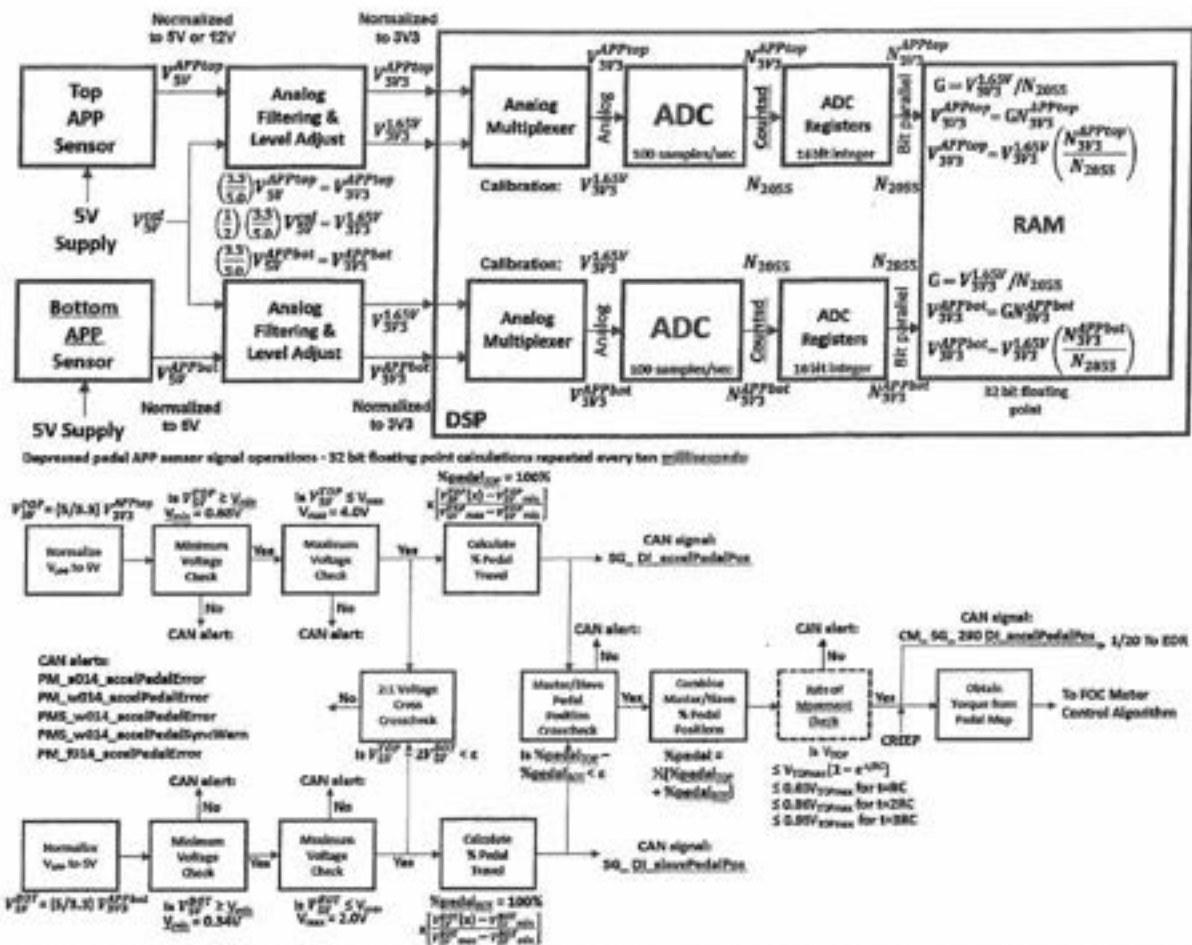
Figure 10. Summary of operations performed on the Model 3 APP sensor signals by the pedal monitor in the TMS320F28377 DSP. CAN alerts and CAN signals replace the OBD-II DTC's and OBD-II connector CAN signals found in most non-Tesla vehicles. There are three kinds of CAN alerts: aXXX (Alert), wXXX (Warning), and fXXX (Fault). The assignment of alerts to specific functions is tentative pending further information from Tesla. The rate of movement check is also tentative at this time.^[11]

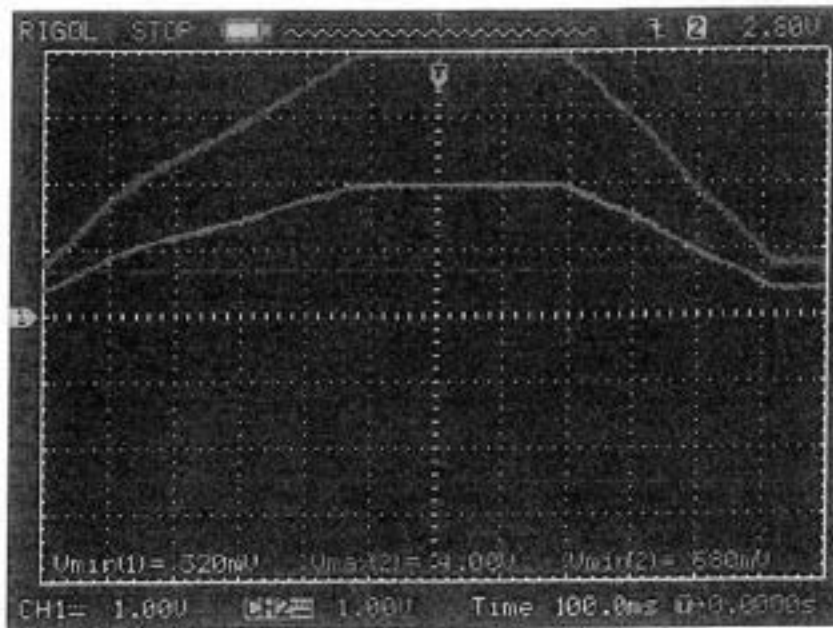
Figure 11 shows that the two APP sensor signals, which are created using separate 5V voltage regulators on the TLF35584QVVS2 PMIC chip, can vary between 0.68 and 4.0V for the top APP sensor and between 0.34V and 2.0V for the bottom APP sensor. Before applying these two APP sensor signals to the inputs of two different ADC's as shown in Figure 10, these voltages must be converted from a 5V basis V_{5V} to a 3.3V basis V_{3V3} by dividing them down using voltage dividers which multiplies them by the ratio 3.3V/5V. The V_{3V3} signals are then digitized by the ADC's, which give the results as a number of counts N_{3V3} based on the maximum ADC signal V_{REF} being 3.3V. The voltage corresponding to this number of counts is the voltage V_{3V3} equal to N_{3V3} times the gain G of the ADC where the gain $G = 3.3V/N_{MAX}$, with N_{MAX} being the maximum number of counts the ADC can produce. For a 10-bit ADC, $N_{MAX} = 1023$ and for a 12-bit ADC, $N_{MAX} = 4095$. The voltages V_{3V3} are then transferred into CPU RAM as 32-bit floating point values. Before any checks can be performed on the two APP sensor signals, these V_{3V3} values must first be converted back into a V_{5V} values by multiplying by 5V/3.3V. Then, the two signals are checked to see if they lie within the limits of the maximum and minimum signals based on 5V. If either

Figure 11. Oscilloscope traces of the APP sensor signals from a Tesla accelerator pedal.^[12] The top sensor is always twice the voltage of the bottom sensor, with the top sensor increasing from 0.68V to 4.0V as the pedal is pressed from 0% to 100% while the bottom sensor increases from 0.32V to 2.0V as the pedal is pressed from 0% to 100%.
